CASE STUDY

SolRnett brings solar system back to life

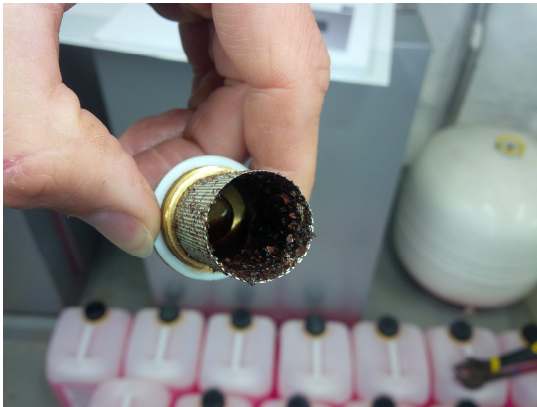
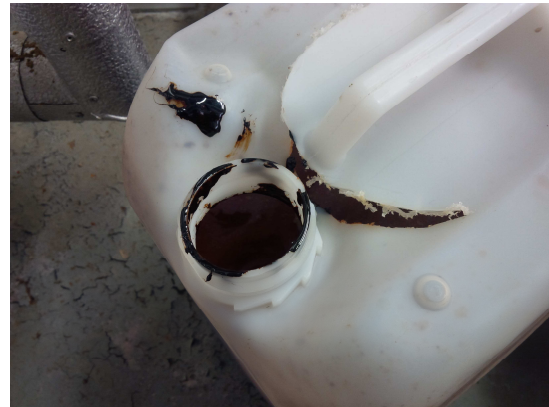
The System: Upon investigation the engineer found that there had been degradation to the fluid originally used in the system (MPG based), which appeared like a sticky tar like residue. This type of problem can sometimes occur when a building is left empty and the system continues to receive energy from the sun. With no outlet for the heat, the system shuts the pump down and slowly heat builds up in the fluid to a point where it degrades. In this particular system it was later found that the purge pump used on installing this equipment had been insufficient and the fluid had stagnated due to air pockets. This had caused the pump to be ineffective. Until recently the only solution to systems with this type of problem has been to completely replace the panels and other system parts – a costly exercise.

The Solution: Griffiths Air Conditioning used the SolRnett product from Climalife, which had a dramatic effect, cleaning the system and enabling them to re-charge with fresh fluid using a suitable purge pump to ensure that no air locks were contained in the system.

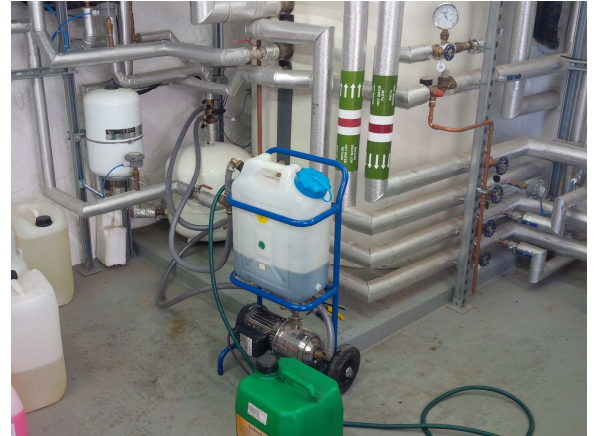
'We left the solution circulating for approximately 1 hour and when the system was drained we found that SolRnett had completely neutralized the degraded glycol, it wasn't even sticky to touch!.

'SolRnett was very easy to use, we first flushed with water, which came back clear, not moving any of the residue, we then followed the SolRnett product data sheet and as soon as it was added to the water the solution turned black, so we knew it was working really well'.
